# EXPONENT

## Millpond status update

Officials: Everything is on track at the Brooklyn Dam project

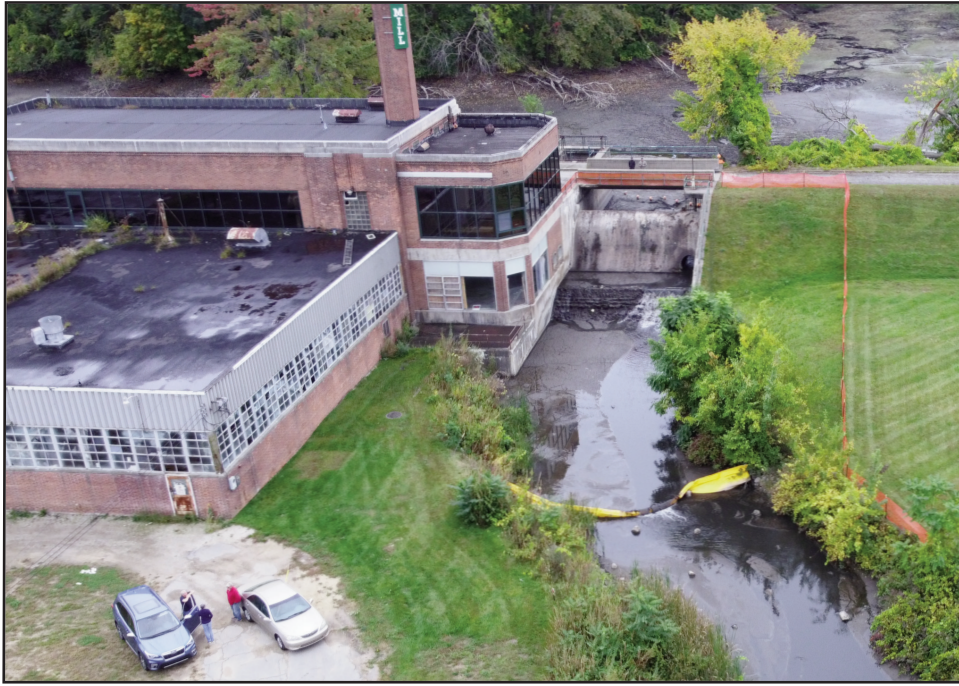
Above: This photo depicts the River Raisin coming through the old Brooklyn Dam during the drawdown. The impoundment, referred to as the “millpond” locally, is in the back. The yellow material you see across the river mid-picture is a turbidity curtain that helped to curtail the flow of sediment moving downstream during the drawdown of the impoundment.

Prior to the drawdown, workers placed a turbidity “curtain” in the river below the dam to slow the flow and try to get some of the sediment to “drop out” and reduce the amount of sediment mobilizing downstream, he explained. Freiburger noted that for that short period, people might have noticed more soft sediment covering the river bottom at Swain Park. “The water was definitely dark in appearance,” he stated.

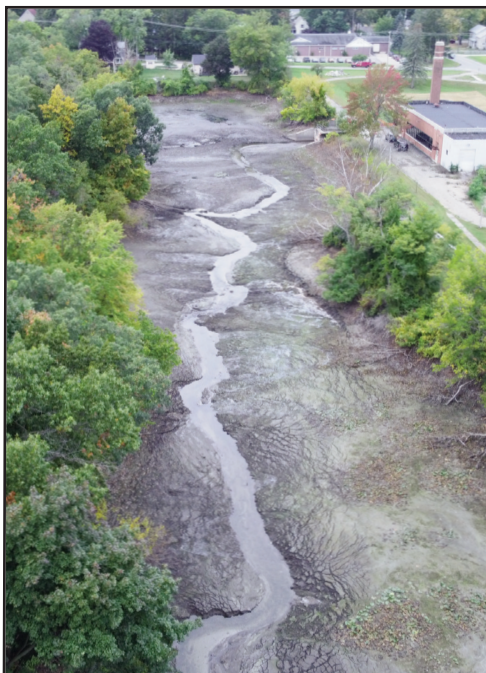
Right: This photo shows the River Raisin just upstream of the Old Irish Mill and the former impoundment directly behind the building. The photos depict the river already adjusting back to a meandering river one week after the drawdown was complete. Project manager Chris Freiburger, says, “They are a great representation of how resilient rivers are, given the opportunity to flow freely. Truly a rebirth of a river.”

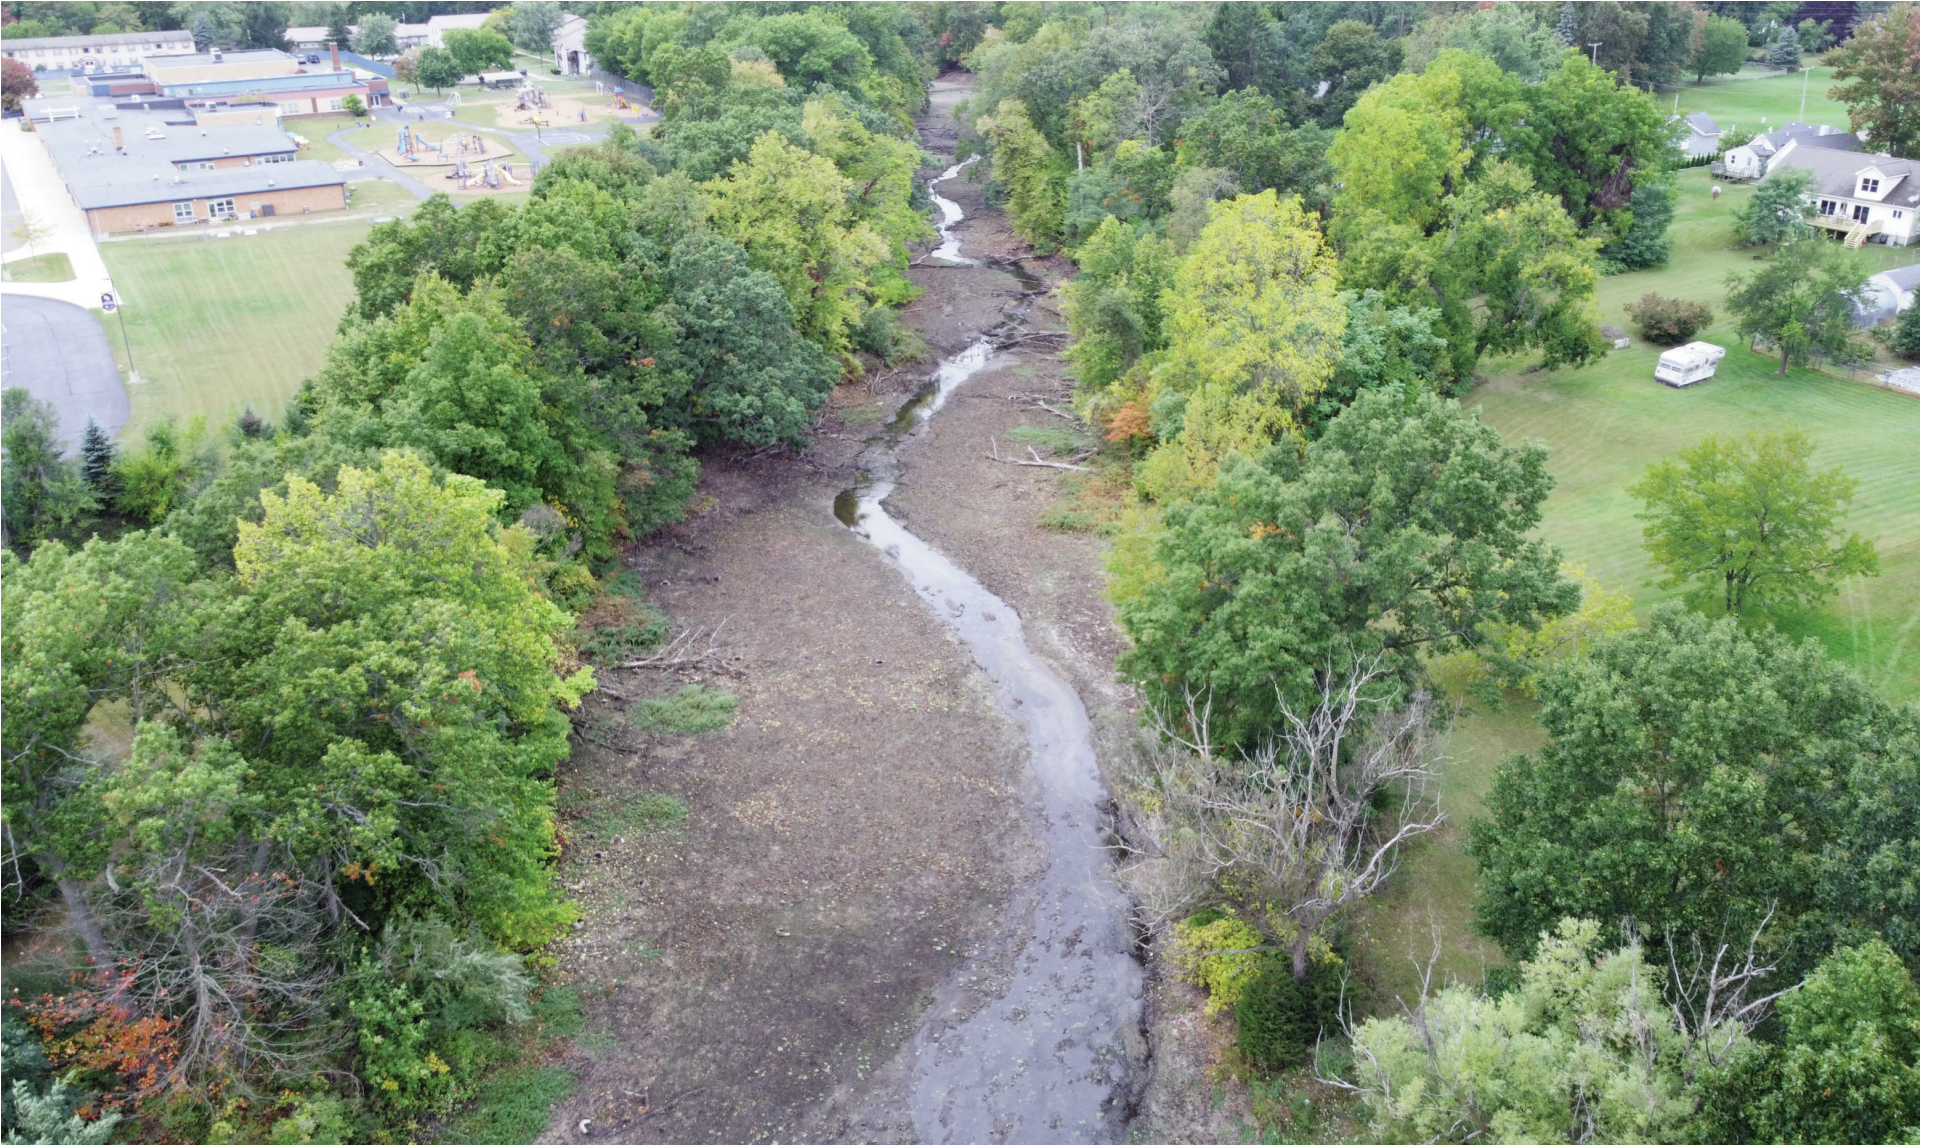
This drone photo, pointing west, shows the Columbia lower elementary school at left and the once-ponded area that has returned to a river.
